# Property Inspection Report

Certified Home Inspection Plus

50465 Via Amante

Date of Inspection: 4/10/2025

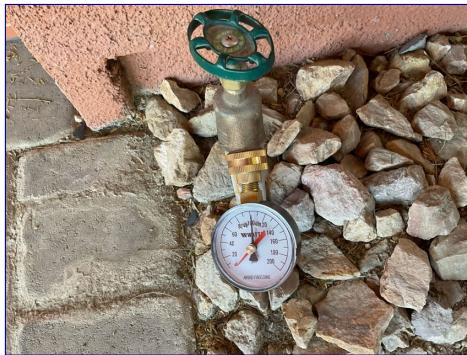
Page 10 Item: 9	Hose Bibs	<ul style="list-style-type: none"><li>The water pressure in the house as measured at the hose bib is greater than 80 psi, which will create additional wear and tear on the plumbing fittings and household appliances. Recommend a licensed plumber repair.</li></ul>
-----------------	-----------	--

100 PSI water pressure--too high.

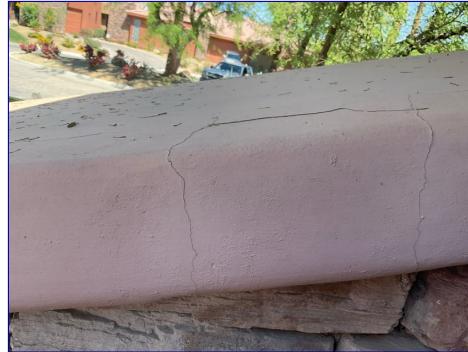
Some of the trim was damaged. Recommend repair or replacement of damaged exterior trim by a licensed contractor. Location front right side by gate.

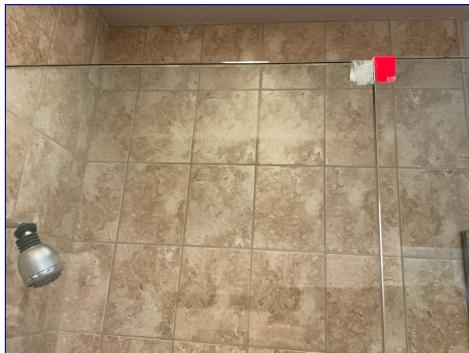
Page 45 Item: 3	Showers	<ul style="list-style-type: none"><li>Glass door needs adjustment. Recommend a licensed plumber repair as needed.</li></ul>
-----------------	---------	---

Glass door needs adjustment.

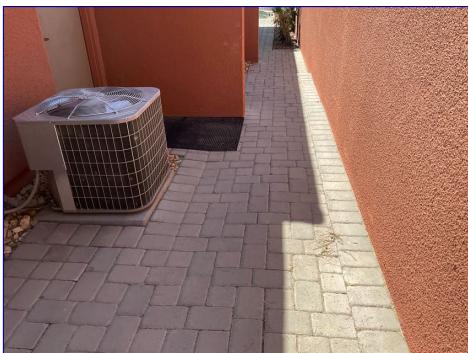
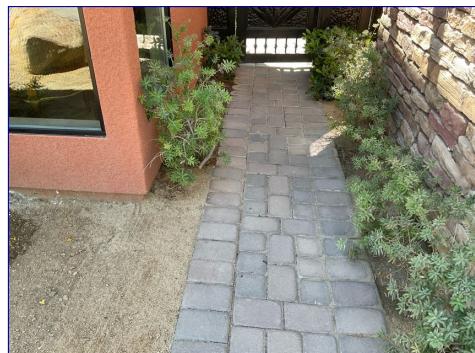
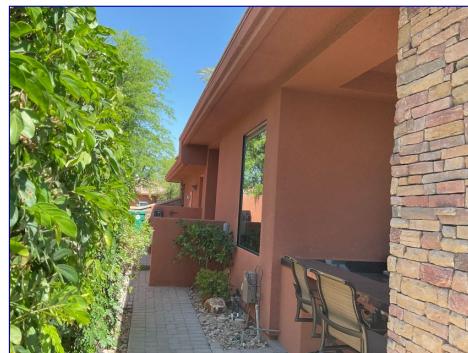
Loose brick by **AC** unit.

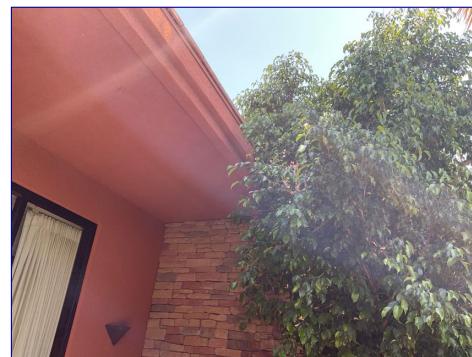
There is vegetation in contact with the house. Recommend trimming trees/vegetation, so it is doesn't come into contact with the home.

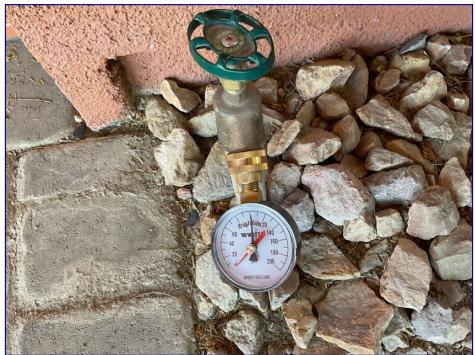
- The lawn sprinkler system is not within the scope of the home inspection. Recommend an irrigation/landscape company evaluation, if needed.
- The water pressure in the house as measured at the hose bib is greater than 80 psi, which will create additional wear and tear on the plumbing fittings and household appliances. Recommend a licensed plumber repair.

100 PSI water pressure--too high.

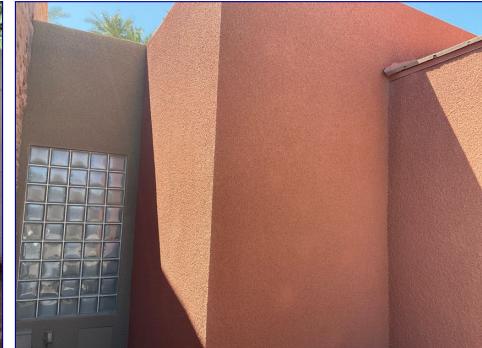
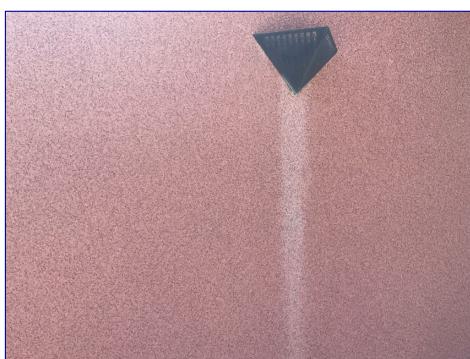
Needs some touch up paint.

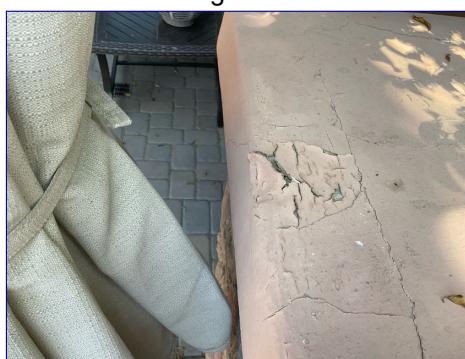
Some of the trim was damaged.  
Recommend repair or replacement of  
damaged exterior trim by a licensed  
contractor. Location on the back side  
east side of home.

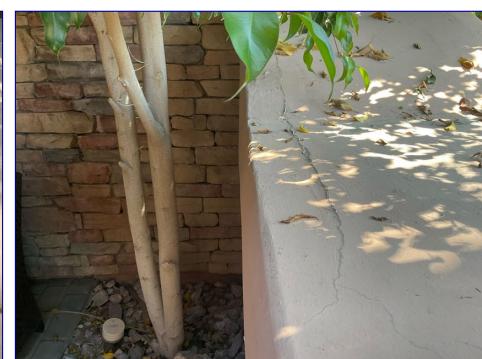
Some of the trim was damaged.  
Recommend repair or replacement of  
damaged exterior trim by a licensed  
contractor.

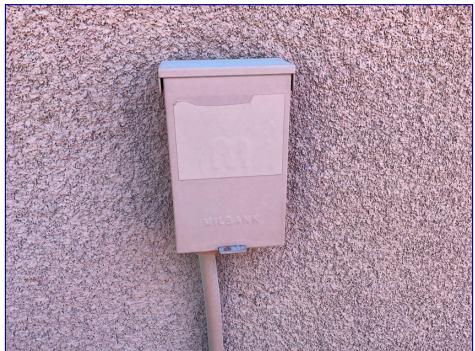
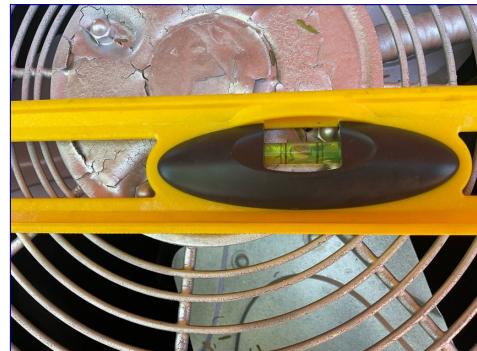
- Serial and model numbers data tag are missing.

No data tag on A/C unit.

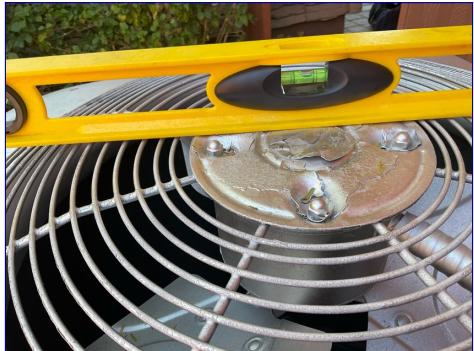
- Model Number: Carrier 38BRC030320
- Serial # 2404E41736
- The air conditioner compressor/condenser data plate.
- The Carrier air conditioner is nearing its expected life of 15-25 years. Recommend budgeting for replacement. Reported marginal due to age.

Based on Carrier serial number, the Carrier A/C unit was installed in 2004.

Serial #2404E41736. Approx 21 years old.

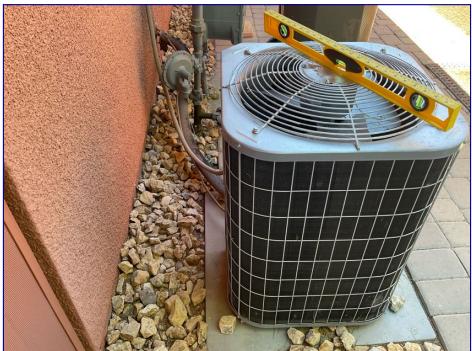
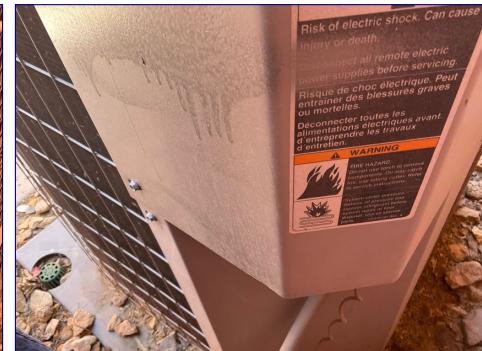
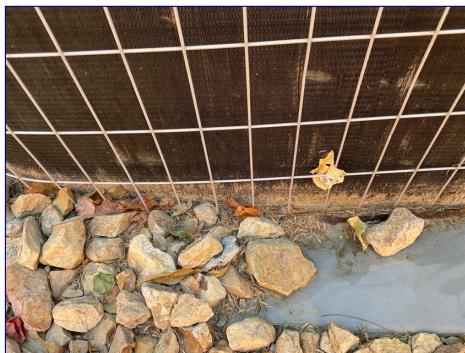
- The air conditioner compressor/condenser data plate missing from A/C unit.
- A/C 3 could use some cleaning on the back side.

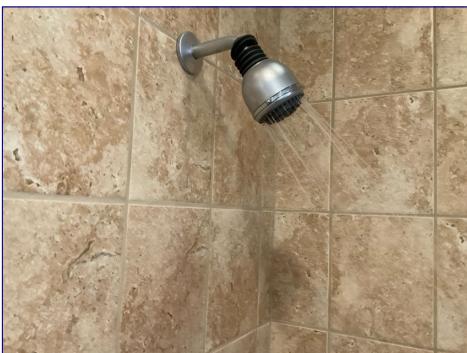
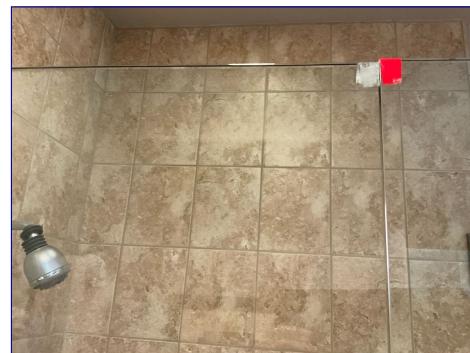
- Glass door needs adjustment. Recommend a licensed plumber repair as needed.

Glass door needs adjustment.

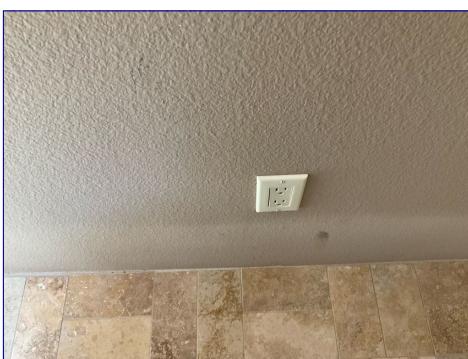
- Marks present on the wall. Recommend cleaning.

Minor marks on the wall

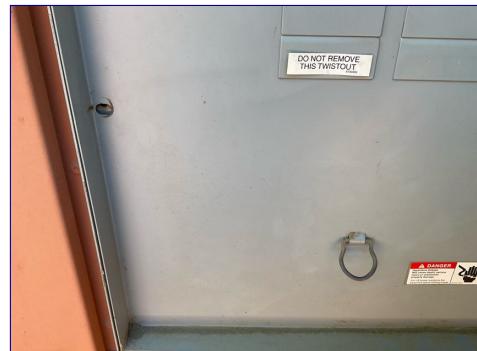
- The main electrical service panel located outside on the west side of home.
- Panel is missing a screw. Repair as needed.

Missing screw on left side of panel.  
Recommend replace.

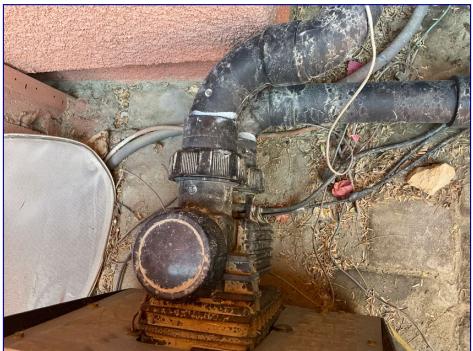
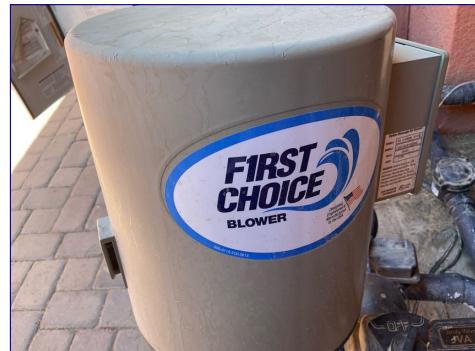
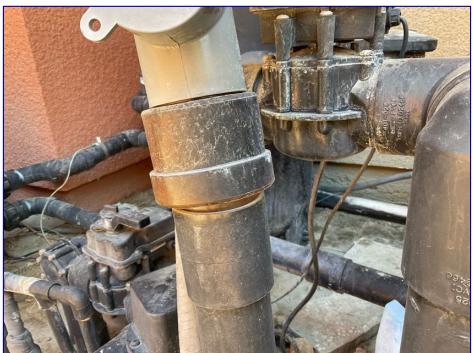
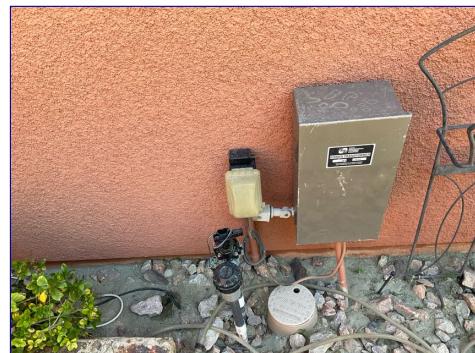
- The air pump,(blower), did operate properly. The piping under the air blower was loose. Recommend repair as needed.

Loose connection below Blower.

Blower not secured.
