# Property Inspection Report

Certified Home Inspection Plus

50465 Via Amante

Date of Inspection: 4/10/2025

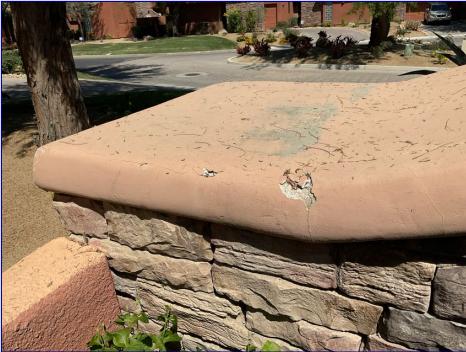
Some of the trim was damaged. Recommend repair or replacement of damaged exterior trim by a licensed contractor.

Some of the trim was damaged.  
Recommend repair or replacement of  
damaged exterior trim by a licensed  
contractor.

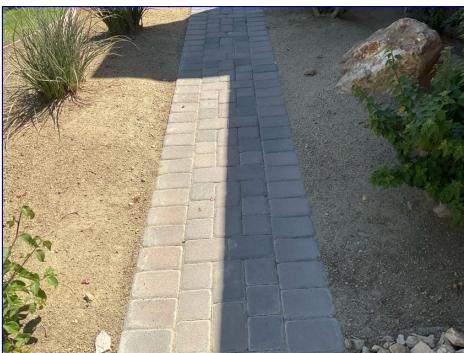
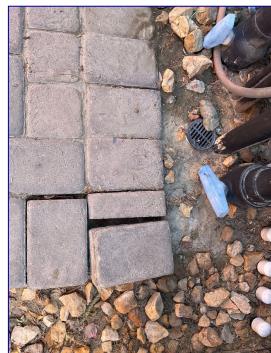
Loose brick by **AC** unit.

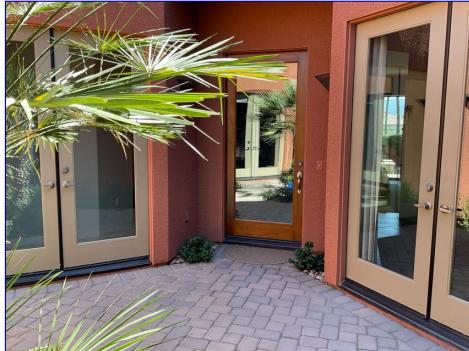
Entry way looks great.

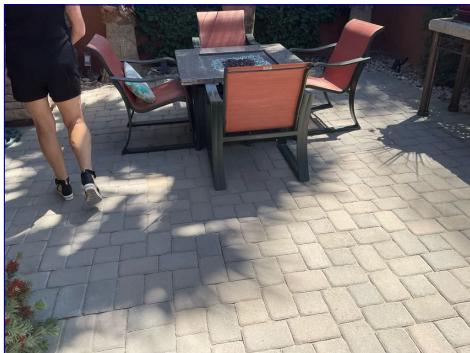
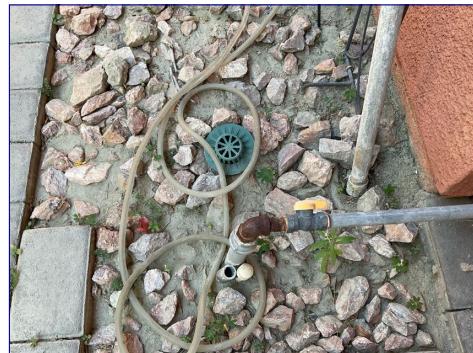
Gas line to barbecue.

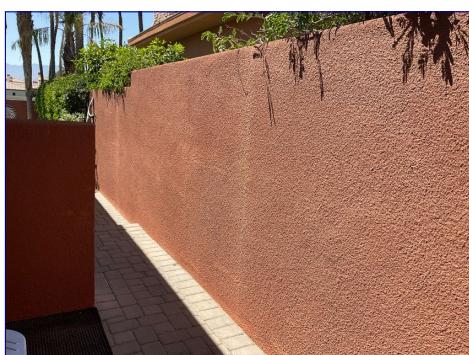
Gates worked well.

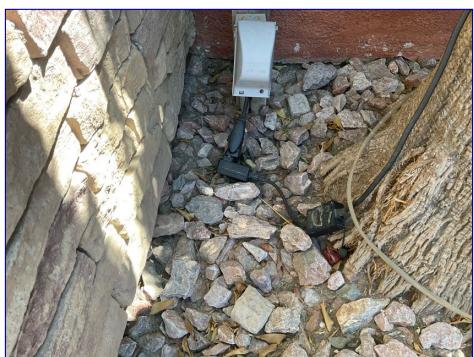
Timer for lights

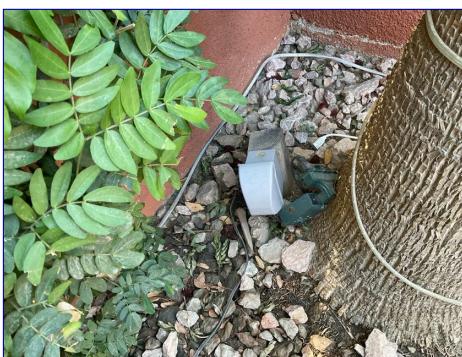
Timers for lights.

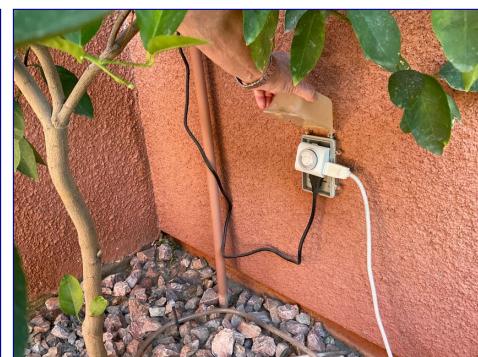
Timer

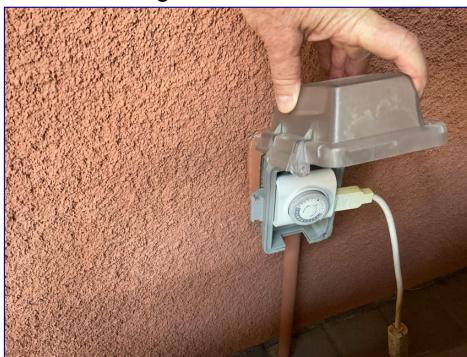
Timer

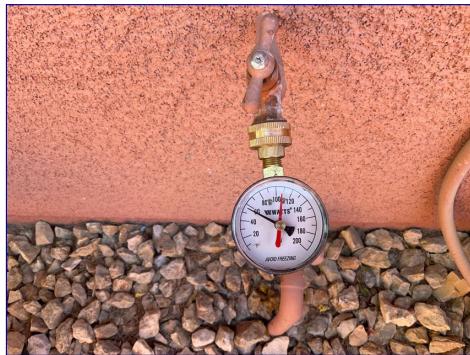
Good pressure 60 PSI.

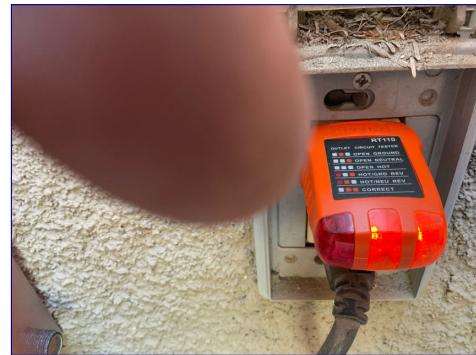
No reverse polarity or open ground.

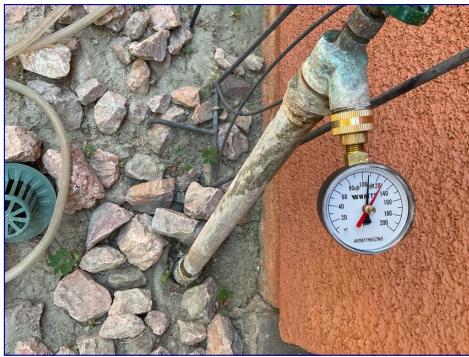
- The lawn sprinkler system is not within the scope of the home inspection. Recommend an irrigation/landscape company evaluation, if needed.
- The water pressure in the house as measured at the hose bib is greater than 80 psi, which will create additional wear and tear on the plumbing fittings and household appliances. Recommend a licensed plumber repair.

108 PSI water pressure. Too high.

Page 10 Item: 9	Hose Bibs	<ul style="list-style-type: none"><li>The water pressure in the house as measured at the hose bib is greater than 80 psi, which will create additional wear and tear on the plumbing fittings and household appliances. Recommend a licensed plumber repair.</li></ul>
-----------------	-----------	--

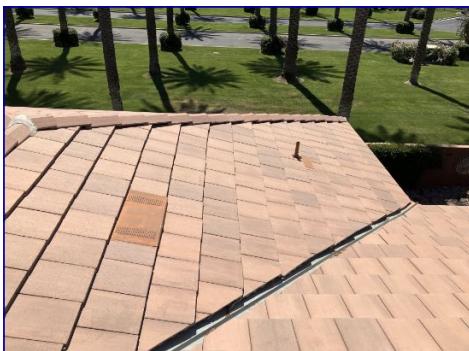
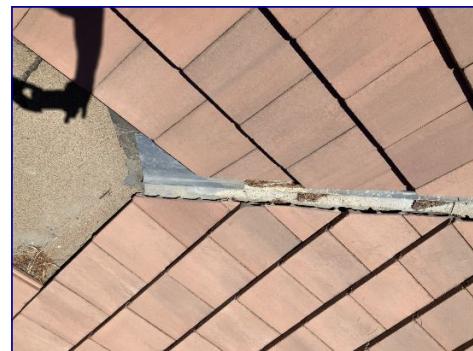
- Inspection of roof covering showed no signs of cracked tiles, at time of inspection.

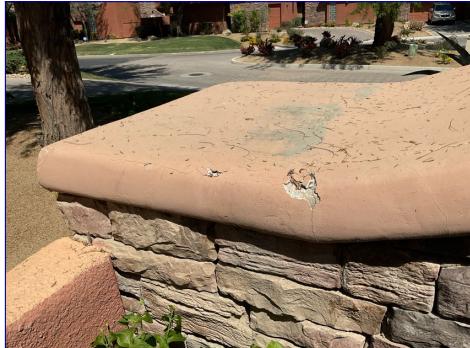
- The exterior trim was in need of normal painting maintenance. Recommend a professional painter repair/paint the exterior trim.

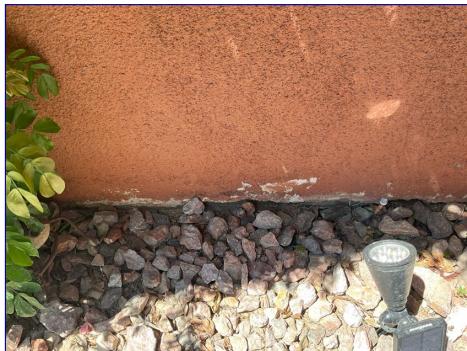
Siding on back wall could use some touched up paint.

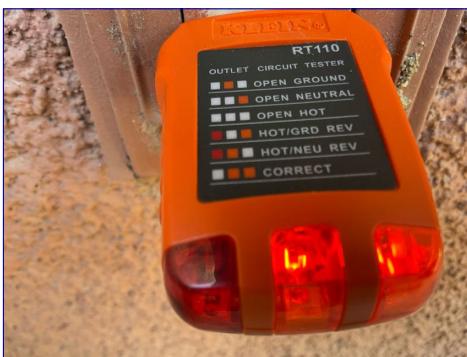
No reverse polarity or open ground.

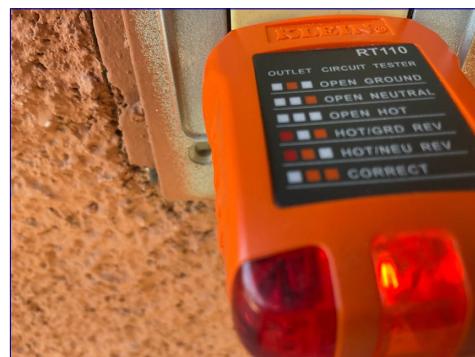
No reverse polarity or open ground.

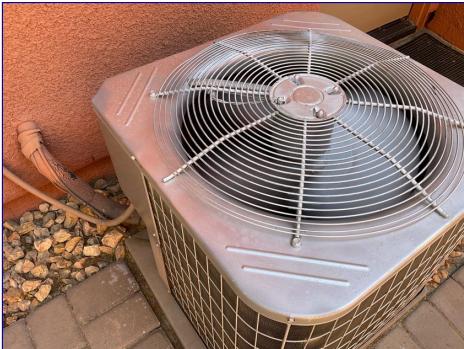
No Data Tag.

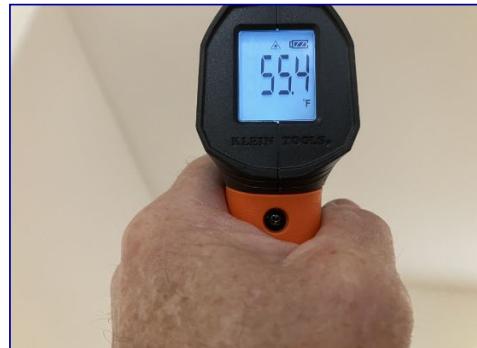
temp test when A/C turned on.

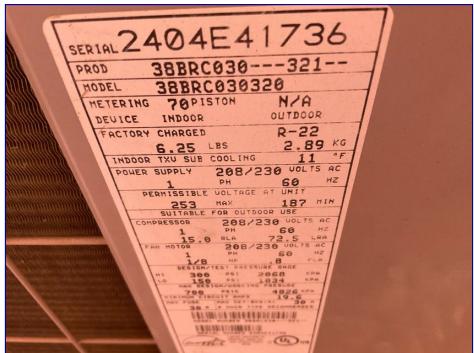
- Model Number: Carrier 38BRC030320
- Serial # 2404E41736
- The air conditioner compressor/condenser data plate.
- The Carrier air conditioner is nearing its expected life of 15-25 years. Recommend budgeting for replacement. Reported marginal due to age.

Based on Carrier serial number, the Carrier A/C unit was installed in 2004.

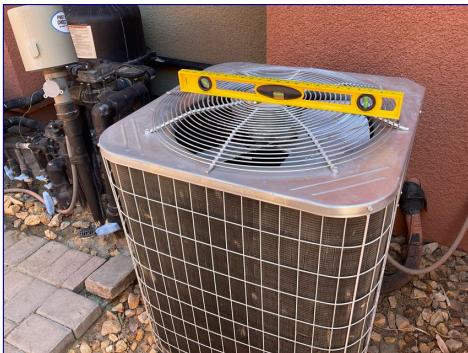
Serial #2404E41736. Approx 21 years old.

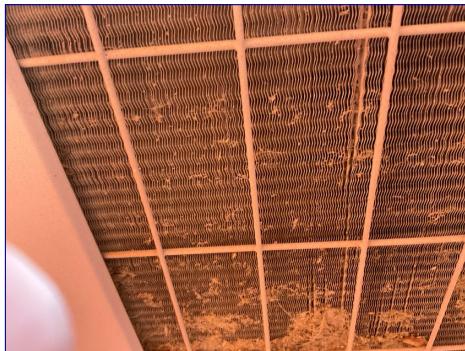
- The air conditioner compressor/condenser data plate missing from A/C unit.
- A/C 3 could use some cleaning on the back side.

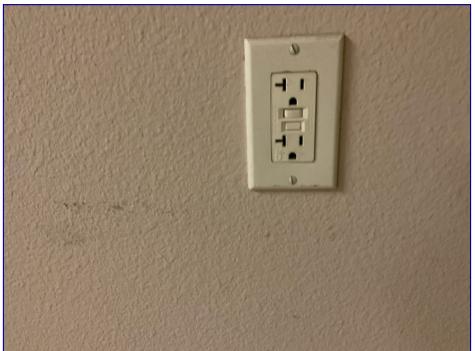
No reverse polarity or open ground.

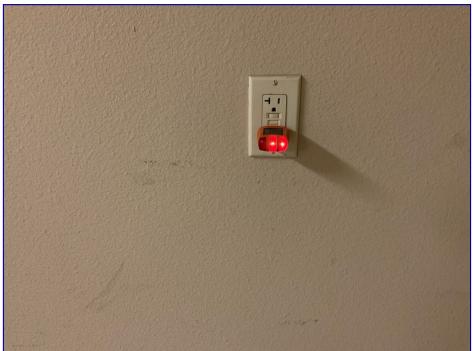
No reverse polarity or open ground.

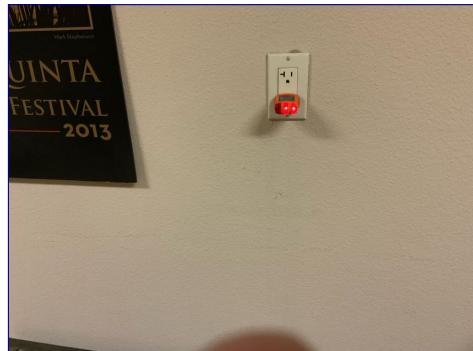
No reverse polarity or open ground.

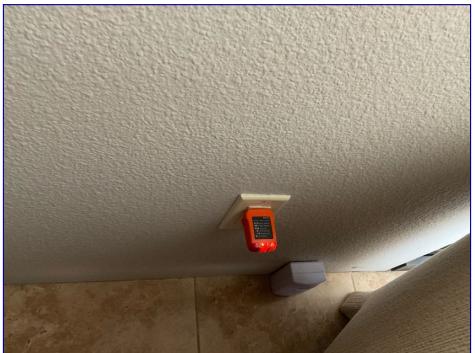
No reverse polarity or open ground.

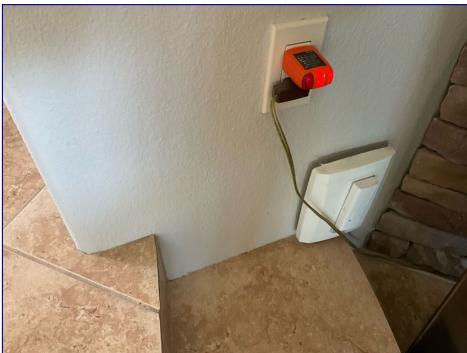
No reverse polarity or open ground.

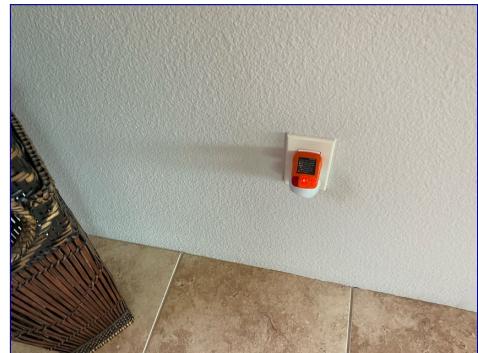
No reverse polarity or open ground.

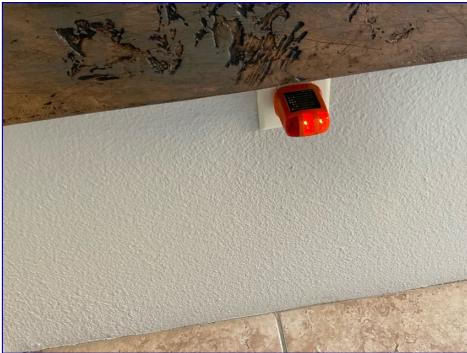
No reverse polarity or open ground.

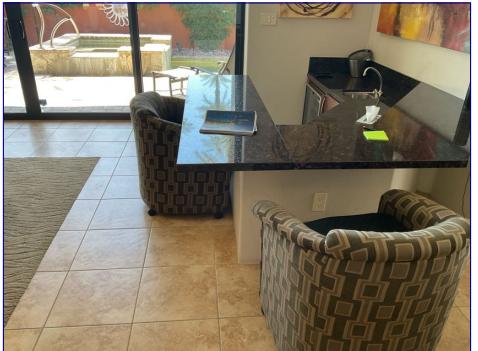
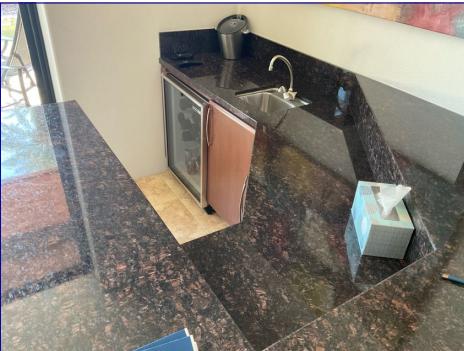
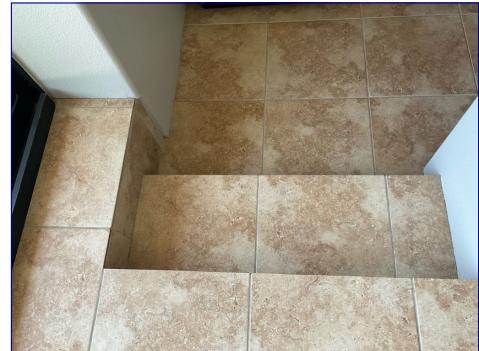
Bar area in great shape.

Bar counters in great shape.

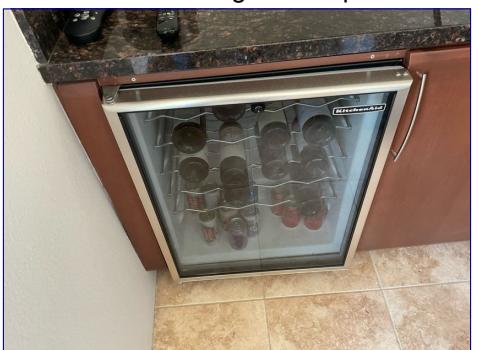
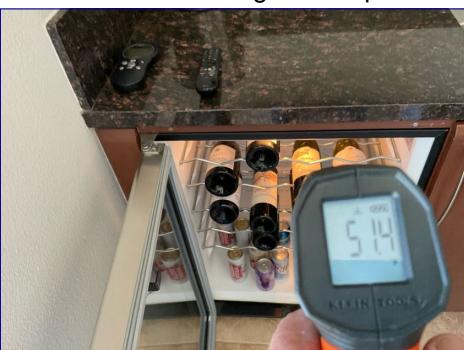
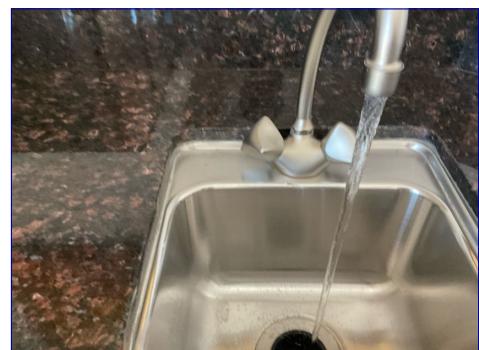
Refrigerator worked properly.

Temperature check was good.

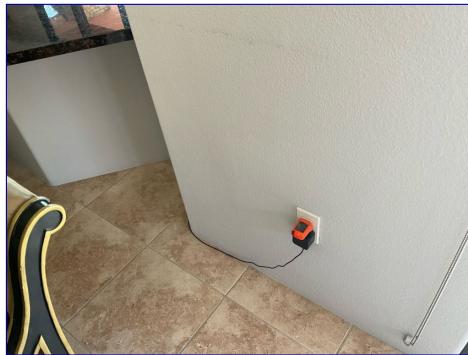
No reverse polarity or open ground.

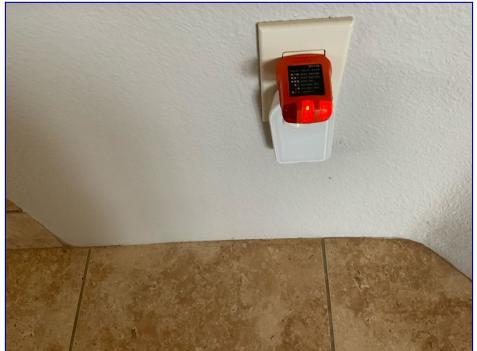
No reverse polarity or open ground.

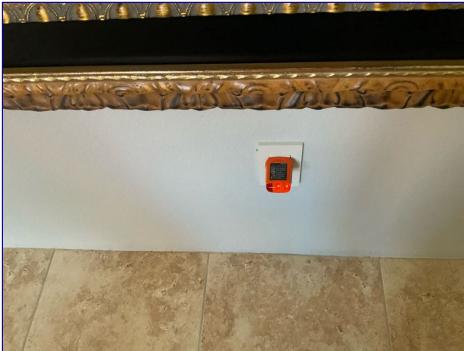
No reverse polarity or open ground.

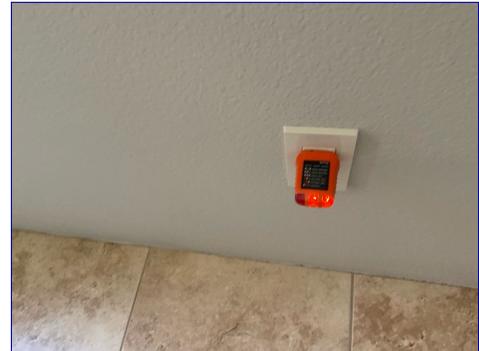
No reverse polarity or open ground.

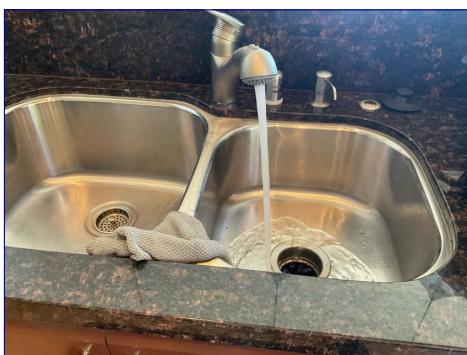
Good water pressure.

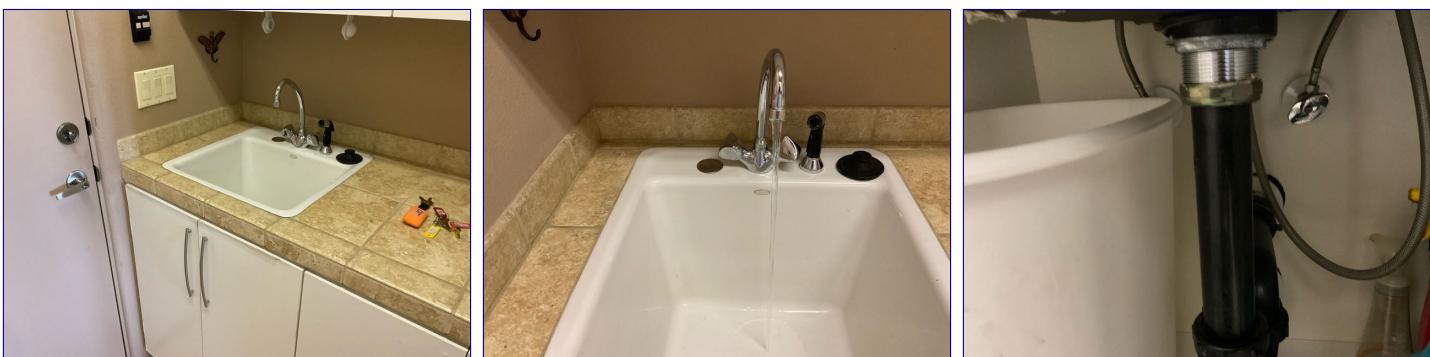
Good water pressure.

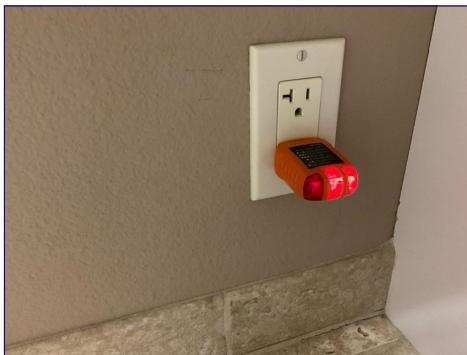
No reverse polarity or open ground.

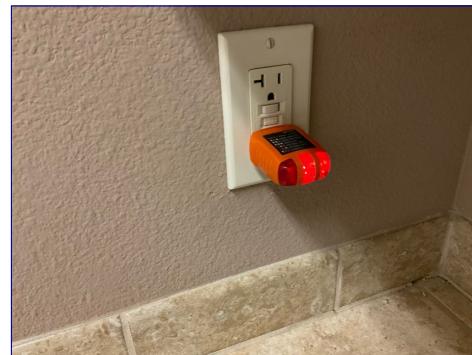
GFI installed. No reverse polarity or open ground.

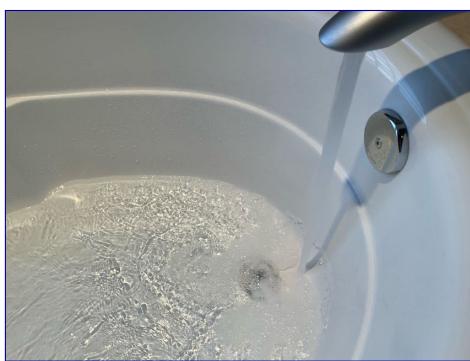
Good water pressure. No leaks.

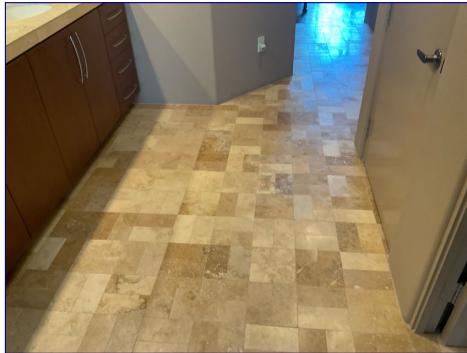
No stains or broken tile on floors or walls.

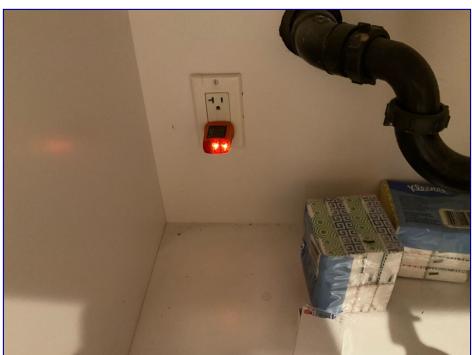
No reverse polarity or open ground.

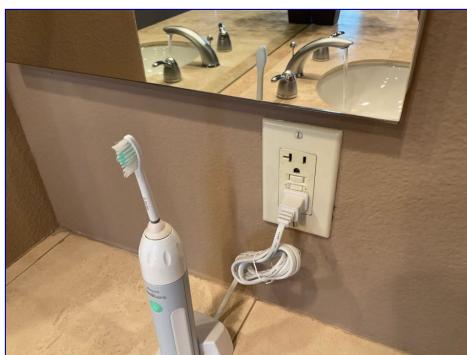
GFCI in bathroom.

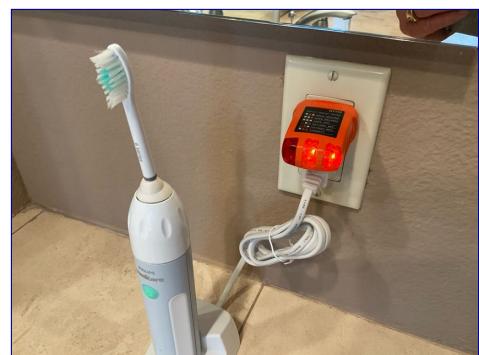
No reverse polarity or open ground.  
GFCI worked properly.

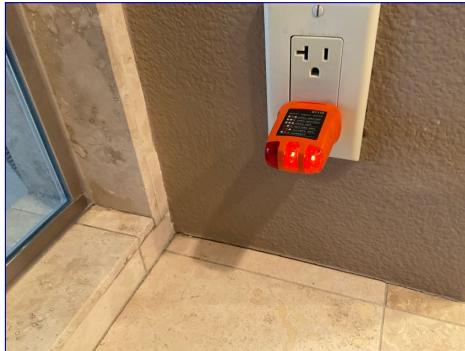
No reverse polarity or open ground.

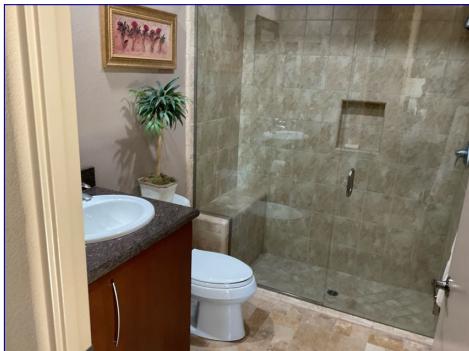
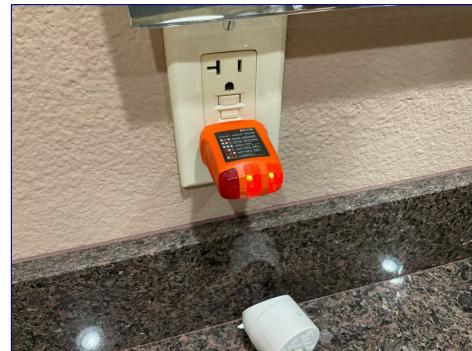
No reverse polarity or open ground. Has GFCI installed.

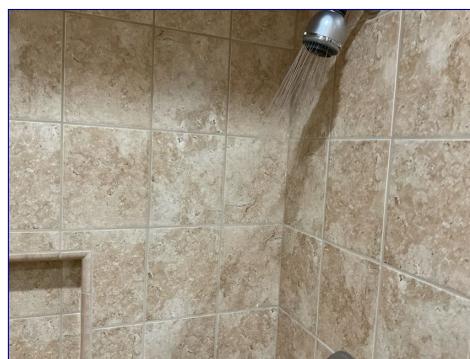
- Faucet leaks: Yes
- Pipes leak: Yes

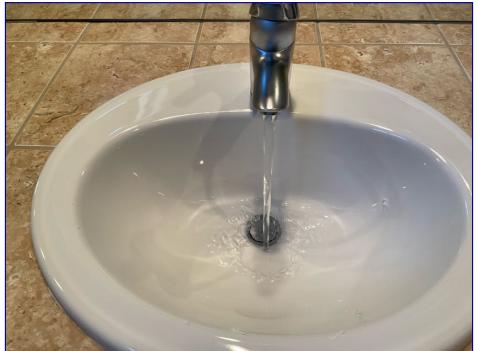
Good water pressure

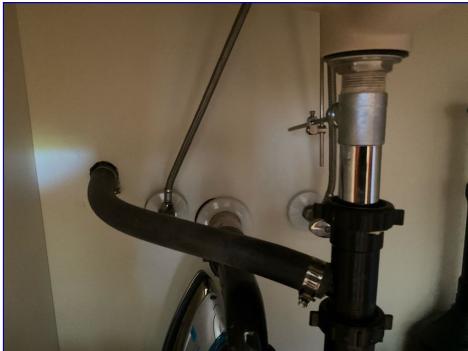
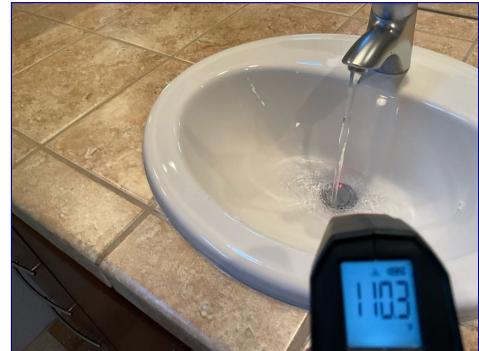
Water temperature test was good. Hot water.

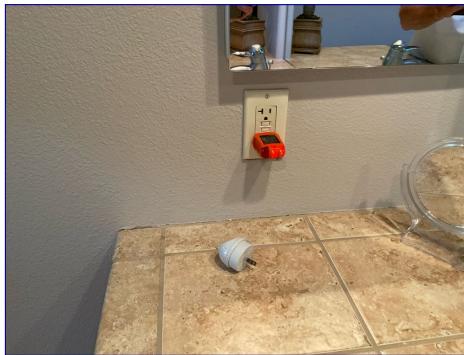
No reverse polarity or open ground.

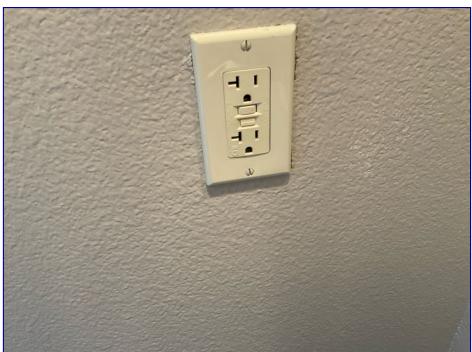
No reverse polarity or open ground.

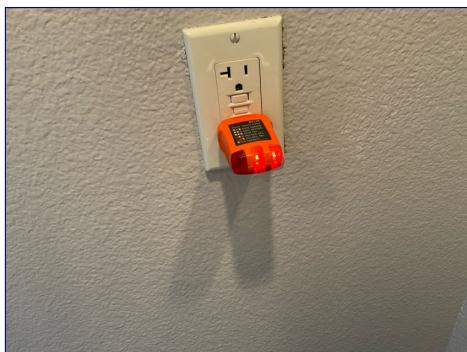
No reverse polarity or open ground.

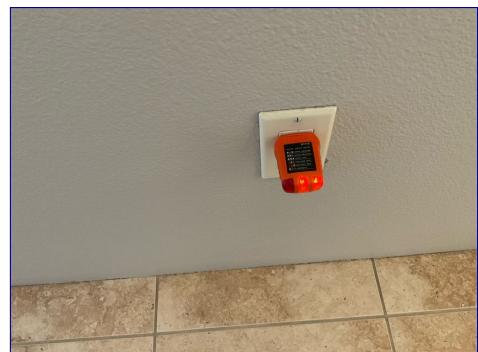
No reverse polarity or open ground.

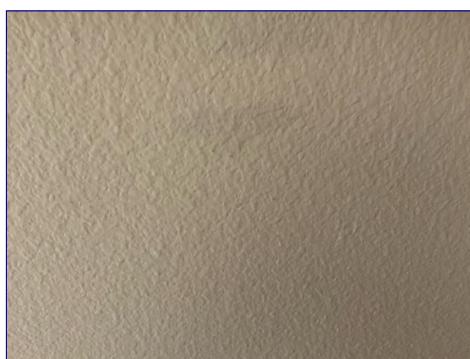
Minor marks on wall

- Marks present on the wall. Recommend cleaning.

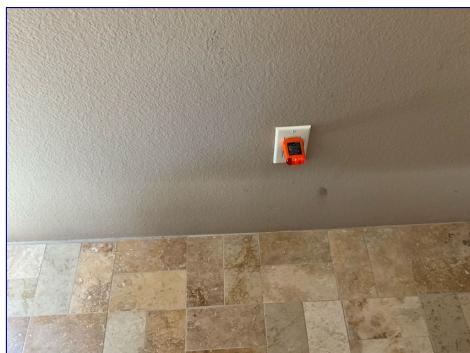
No reverse polarity or open ground.

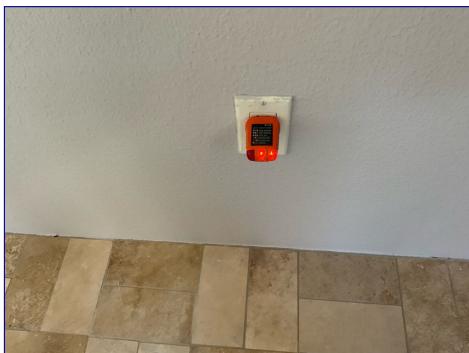
No reverse polarity or open ground.

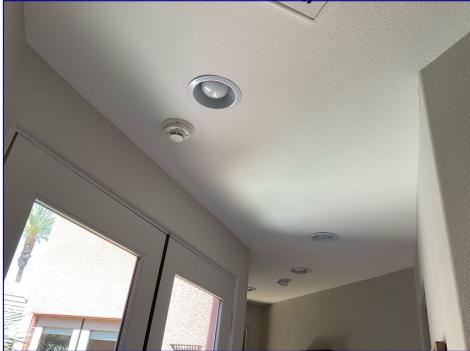
- The Hallway View. Has a few marks on the walls. Repair as needed.

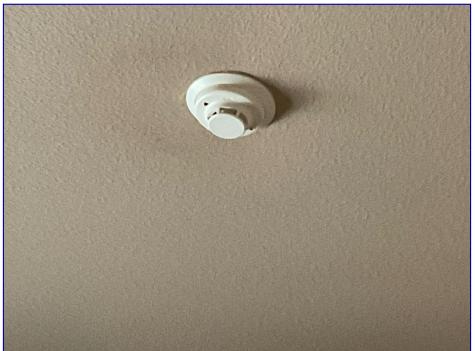
Working smoke alarm in primary bedroom.

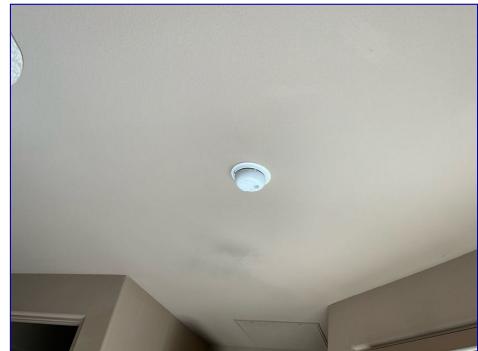
Bedroom 2 has a working smoke alarm at time of inspection.

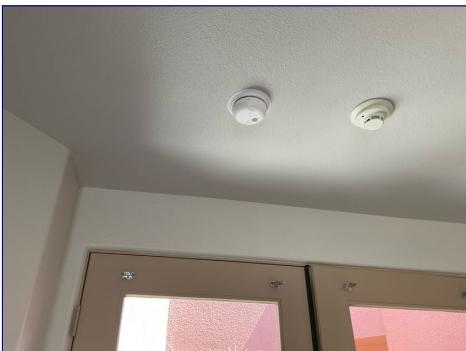
Bedroom 3 working smoke detector. (Casita)

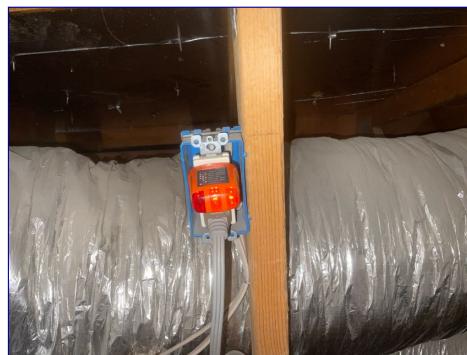
No reverse polarity or open ground.

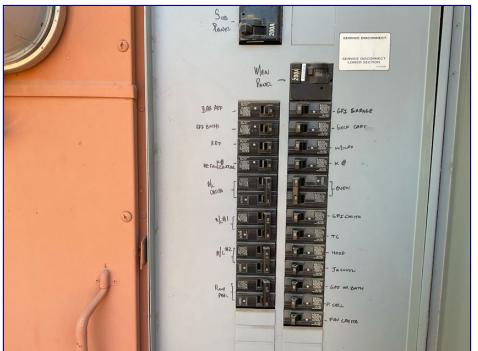
Outside on west side.

- The main electrical service panel located outside on the west side of home.
- Panel is missing a screw. Repair as needed.

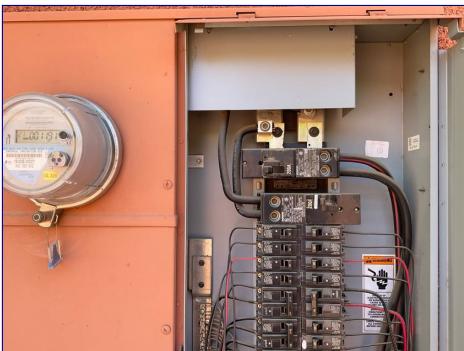
Missing screw on left side of panel.  
Recommend replace.

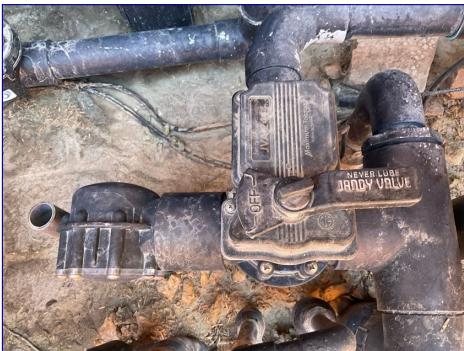
- The air pump,(blower), did operate properly. The piping under the air blower was loose. Recommend repair as needed.

Loose connection below Blower.

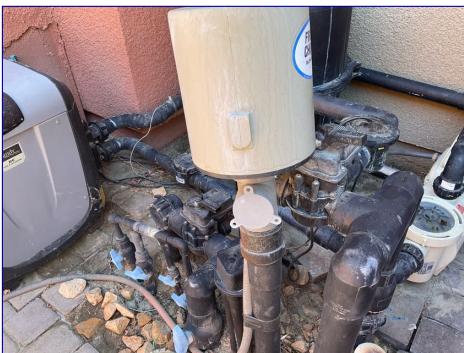
Blower not secured.

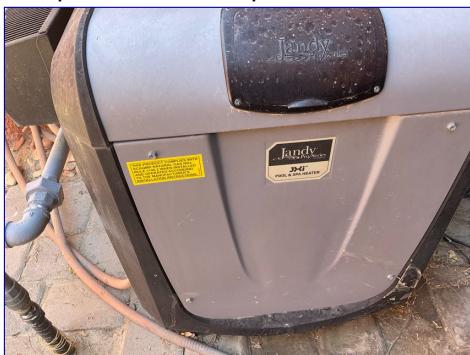
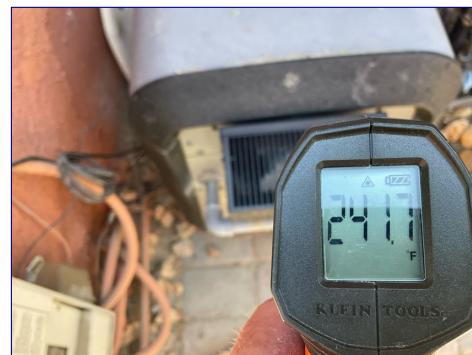
Temperature was good.

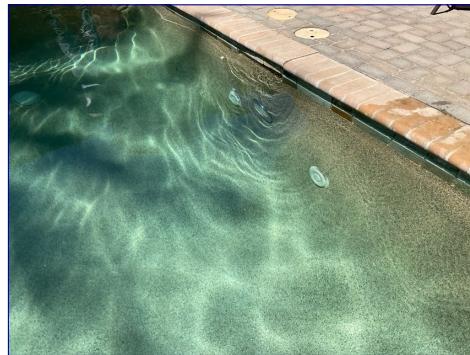
Lights in spa and pool worked well.

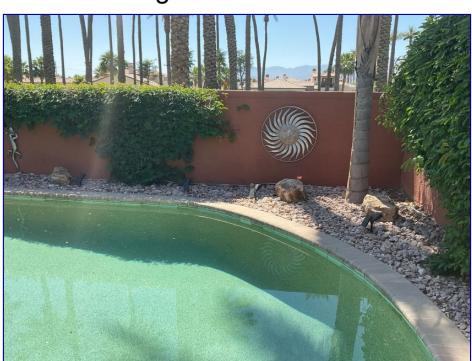
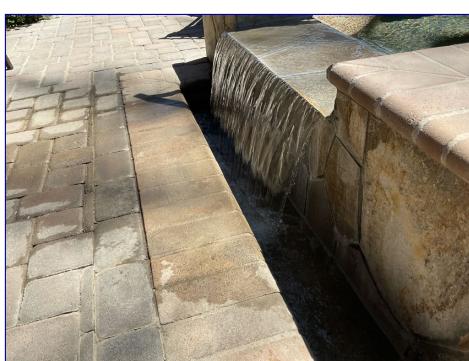
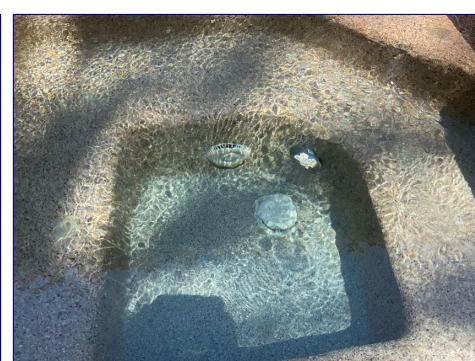
## 11. Structure Condition

Water fall and jets work well.

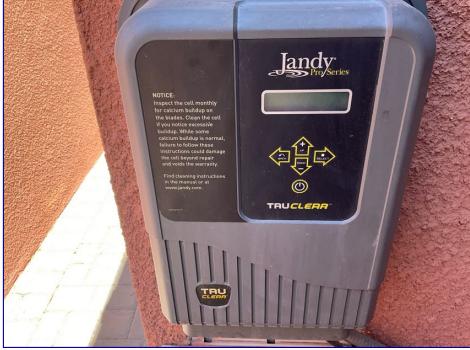
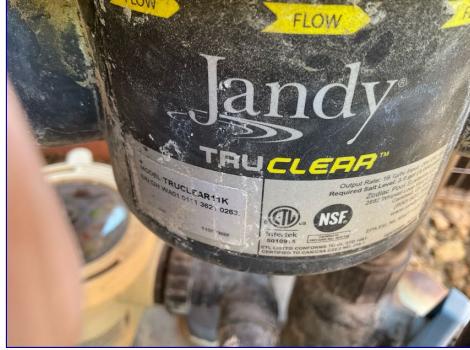
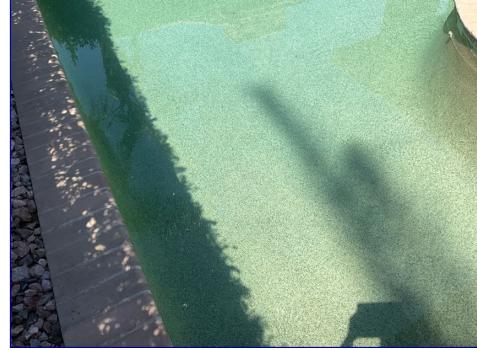
## 13. Water Condition

- Clear

True Clear works fine.

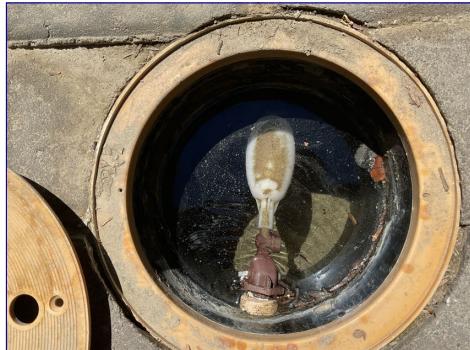
## 14. Water Fill Unit

- Operated

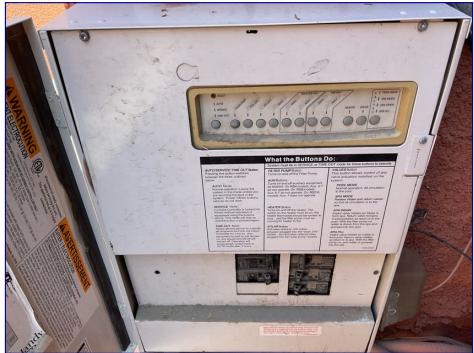
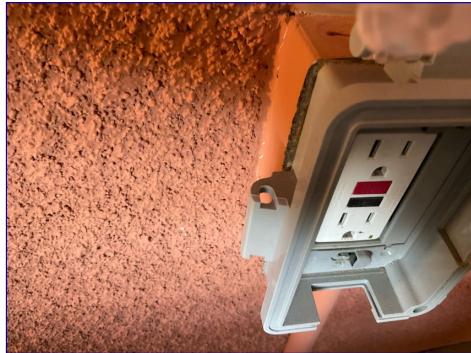
## 15. Electrical

- No major system safety or function concerns noted at time of inspection.
